## **UNIVERSIDAD DE CANTABRIA**

### Biofouling Research Group

# **RECUBRIMIENTOS CERÁMICOS BIOACTIVOS PARA LA OPTIMIZACIÓN ENERGÉTICA EN LA INDUSTRIA NAVAL PESQUERA**

# **BIOACTIVE CERAMIC COATINGS FOR ENERGY OPTIMIZATION IN THE FISHING NAVAL INDUSTRY**

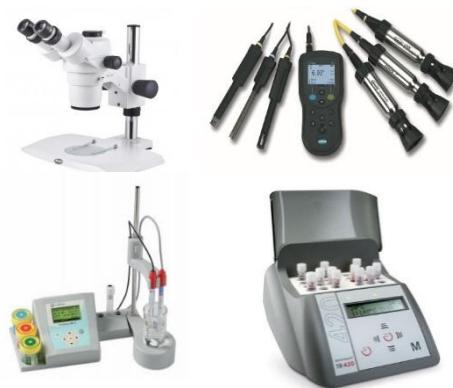
# Biofouling assessment in Marine Laboratory

- Experimental plates were submerged during 365 days in the shallow marine environments, at a depth of 0.5 m (06 February 2024 - 06 February 2025), Monthly - visual inspection following the ASTM D 3623-78a.
- Temperature of seawater was measured daily during the experiment period. Daily-  $\text{mS m}^{-1}$ , pH and  $\text{O}_2$ .
- Measurement of barnacle adhesion strength in shear as follow ASTM D5618-94.
- Analysis quantitative and qualitative of biofouling on sampled surfaces.
- The evaluating biofouling resistance and physical performance of marine coating system in related ASTM D6990-05.

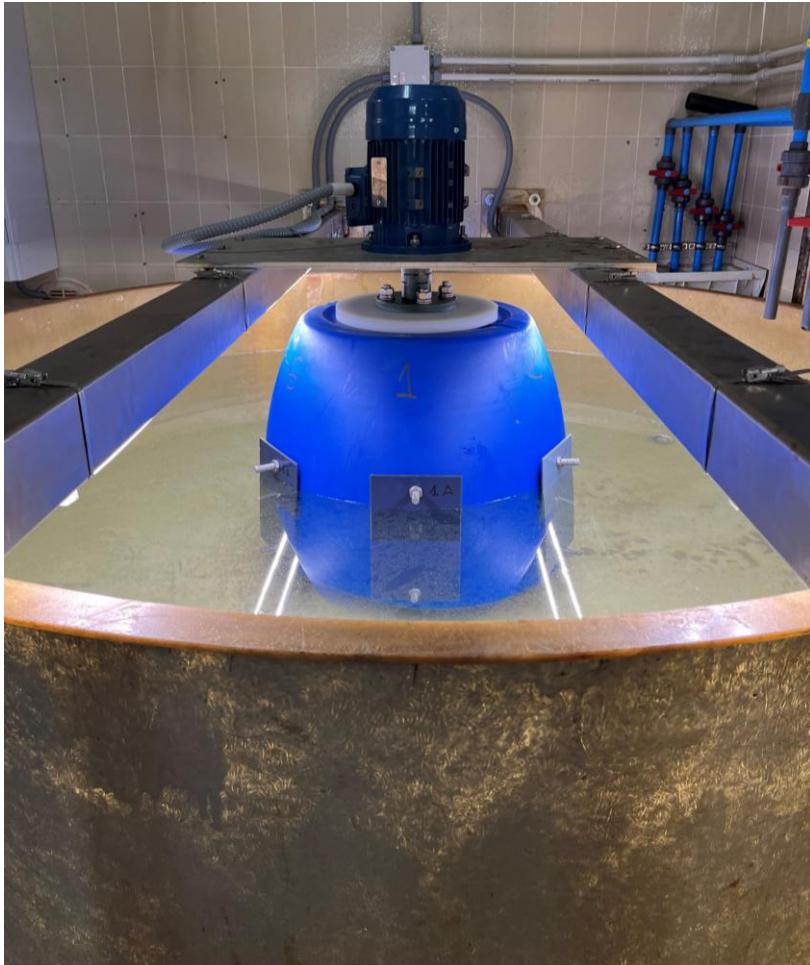
# Biofouling assessment in Laboratory

Roughness in laboratory ( $\mu\text{m}$ )			
	0-months exposure		1-months exposure	12-months exposure
		Static conditions	Dynamic conditions	Dynamic conditions
Ceramic coating	0,721	8,3	2,1	103,4
Paint	72	73	73	203,5

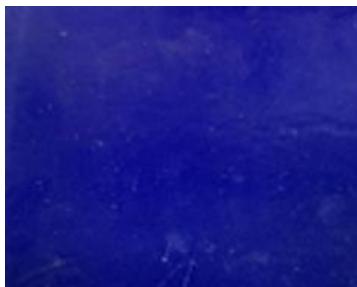
0 day exposed

# Antifouling performance of Ceramic Coating

Fouling rating %	Physical Condition (Defects) %	% Cover			
		filamentous bryozoans	barnacles	algae	Biofilm
85	22	13	27	40	20

Roughness: 0.721 µm  
Thickness: 217 µm

Material	Roughness in marine laboratory ( $\mu\text{m}$ )		
	0-months exposure	1-months exposure	12-months exposure
Ceramic coating	0,721	10,2	1457,14
Paint	72	76	273,63

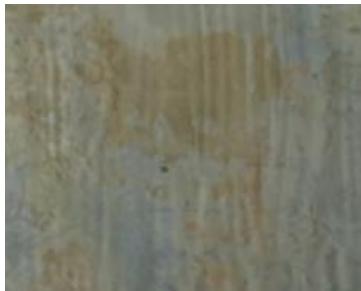
0 day exposed

## Antifouling performance of Paint

Fouling rating %	Physical Condition (Defects) %	% Cover			
		filamentous bryozoans	barnacles	algae	Biofilm
95	74	20	3	27	50

Roughness: 72 µm  
Thickness: 300 µm

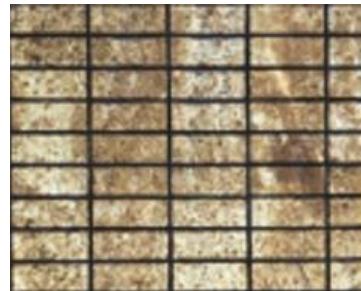
365 day exposed

Before washing

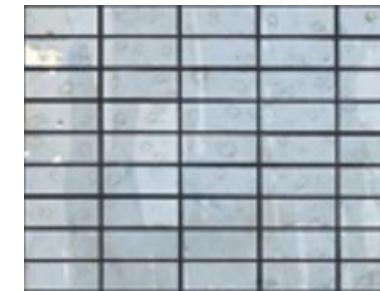
After washing
